ENSIGN BICKFORD DAM
CT 00567

FARMINGTON RIVER BASIN
SIMSBURY, CONNECTICUT

PHASE I INSPECTION REPORT
NATIONAL DAM INSPECTION PROGRAM

Ensign Bickford Dam
CT 00567
Town of Simsbury, Hartford County, Connecticut
On the Hop Brook
Owned and Operated by The Ensign Bickford Company

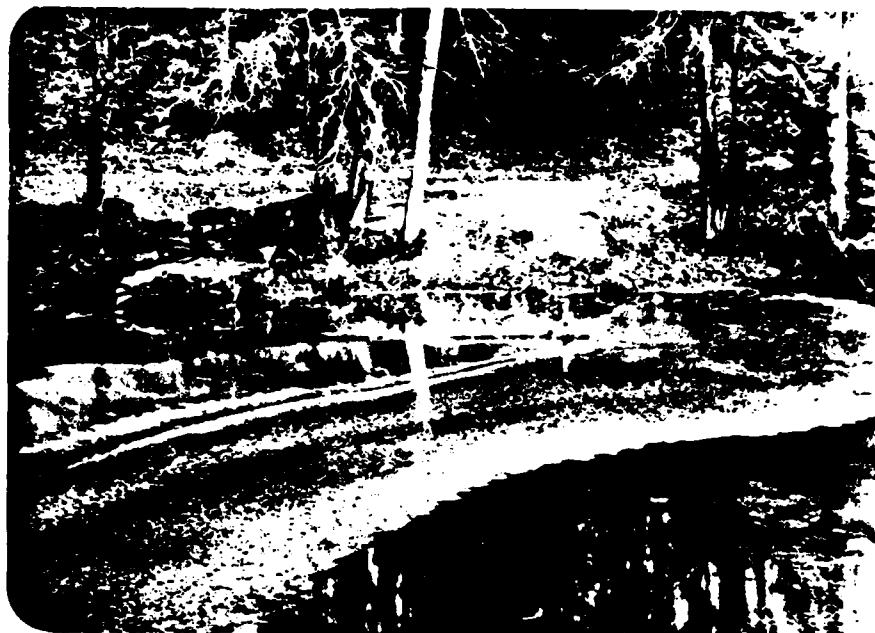
PHOTO NO. 11

RIGHT ABUTMENT. NOTE OPERATOR
IN POND FOR STONE MASONRY SLUICEWAY
